**Abridged
Investigation Report**

Ammonium Nitrate Explosion

Angellala Creek, Charleville Queensland

Australia on 5th September 2014

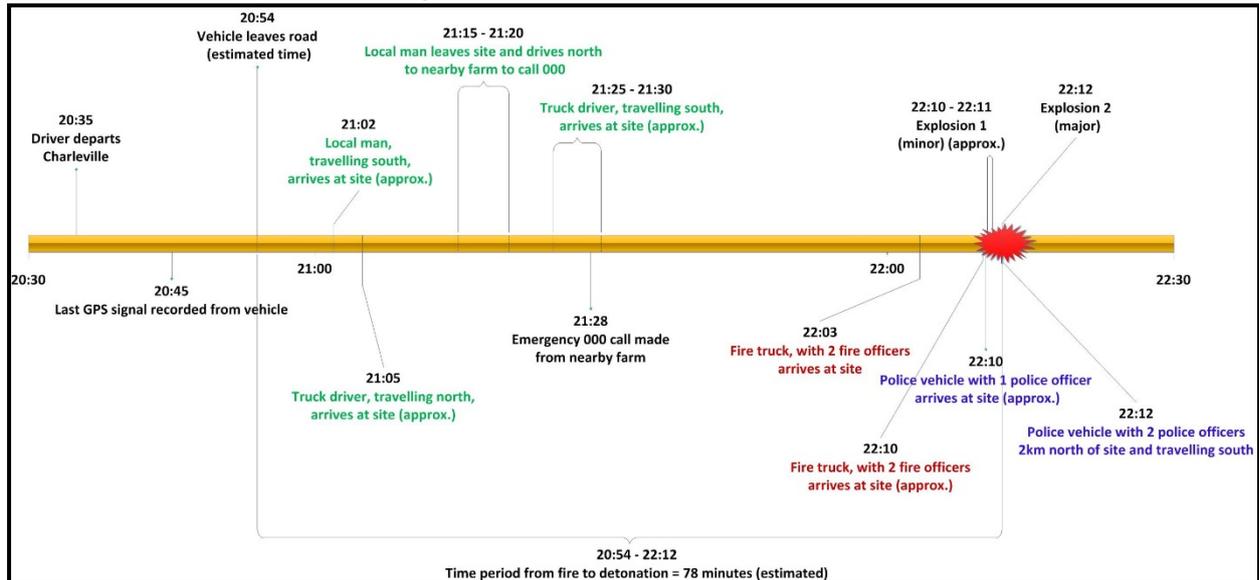
Brief timeline of the incident at Angellala Creek.
