# **SCAT Incident Investigation Report**

## **Test Assembly Falls from Rig Floor**

**Rig: 185**

**Incident Date: 30 June 2014**

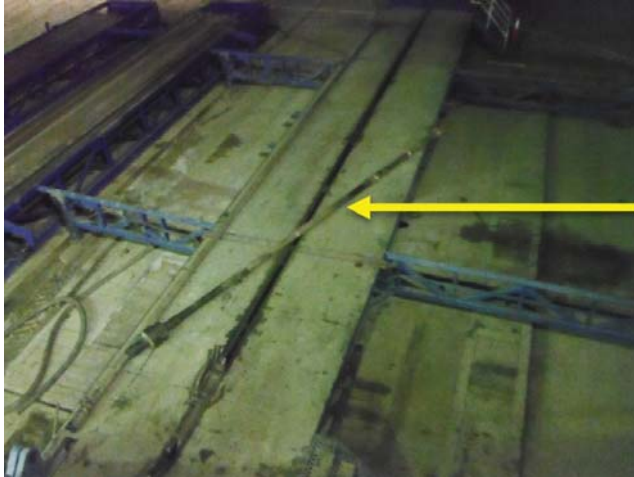
**Final Resting Position of Test Assembly**

The 7.5m (approximately 160kg) test assembly, including the combination tool, slid down the V door, struck the skate and came to rest on the catwalk.

Resting location of assembly on catwalk

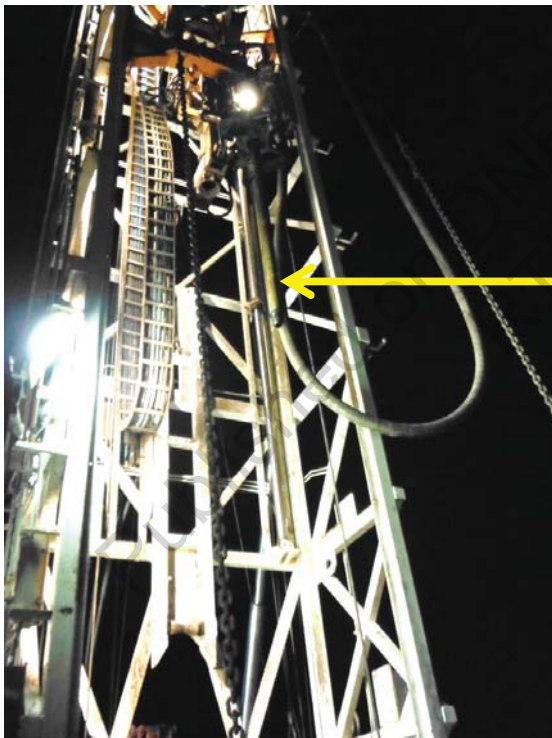
**PUP Joint hanging from Elevators**

The joint between the 3.4m pup joint and the side entry sub backed out. The Driller did not notice the joint above the side entry sub being backed out.

Joint remaining in elevators

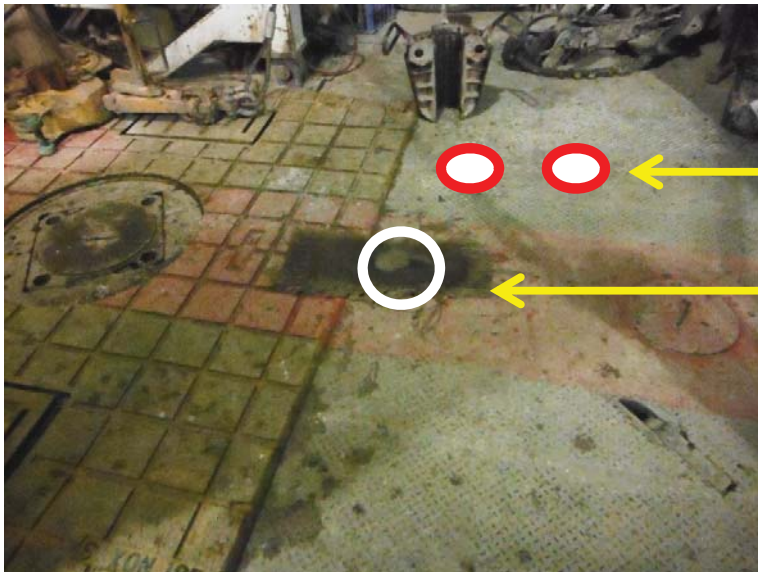
**Rig Floor**

Position of crew on Rig Floor

Location of combination test tool when screwing in

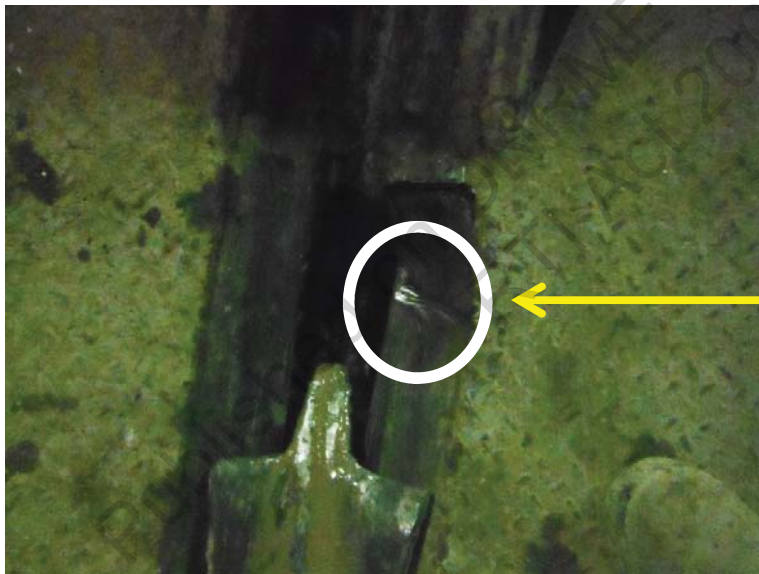
**Catwalk Skate**

Damage to skate

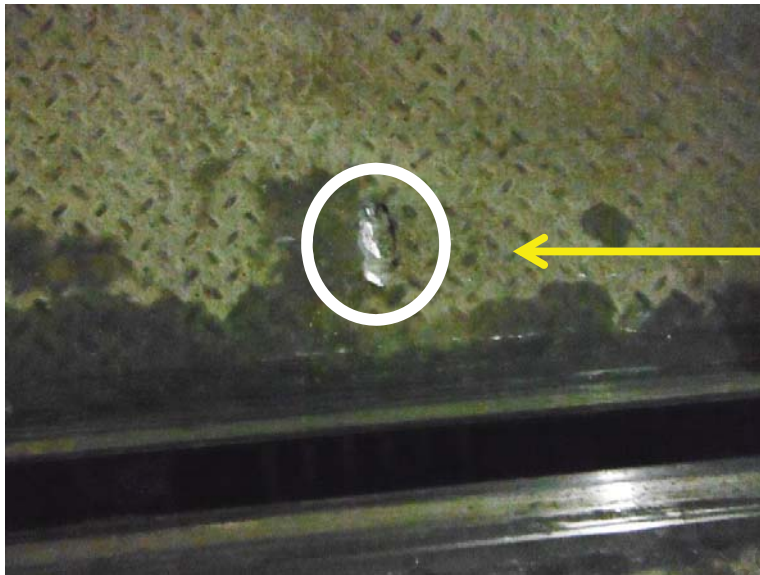
**Catwalk (1)**

Damage to catwalk

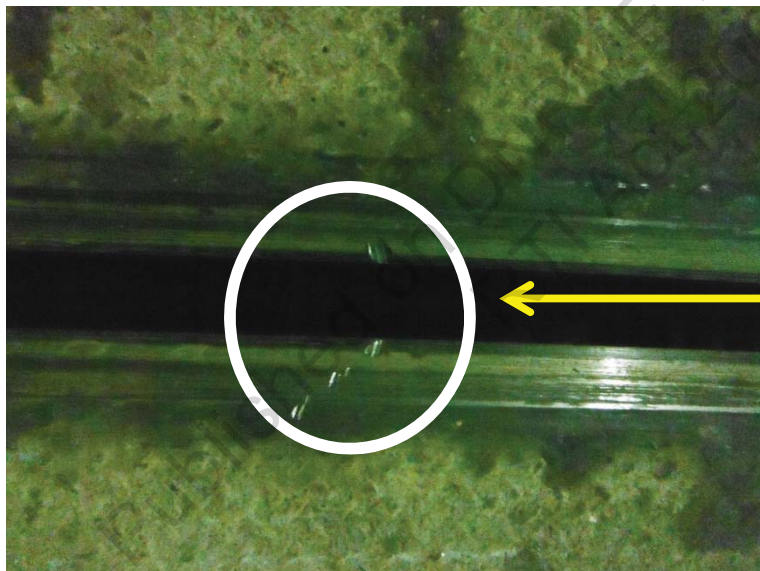
**Catwalk (2)**

Damage to catwalk

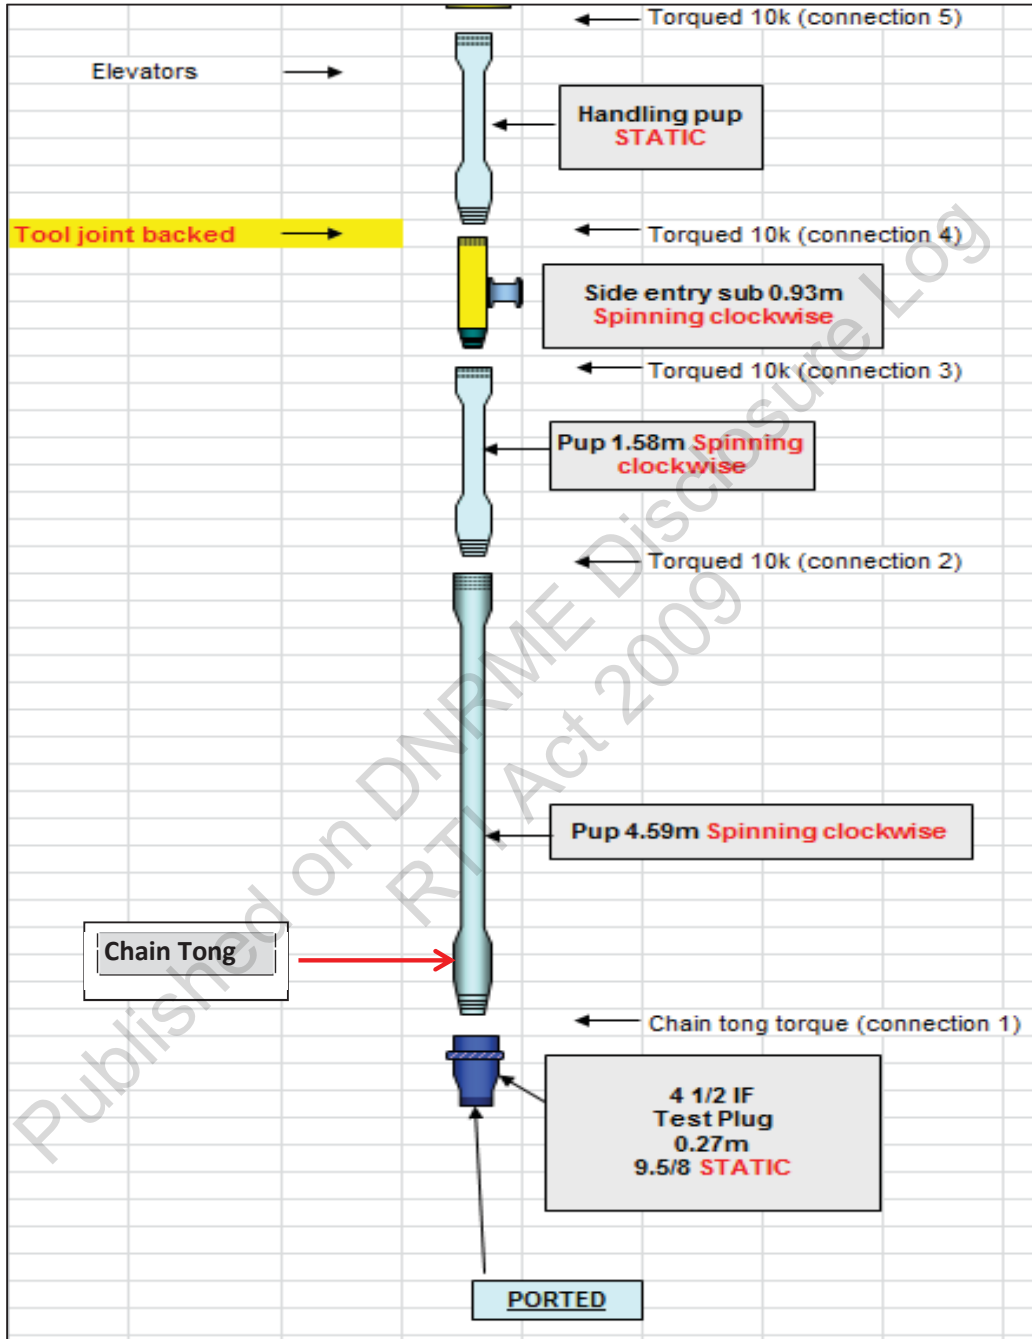
**Test Assembly Make up**

*When screwing in from the top down in to the test plug, the connection between the pup joint and side entry sub unscrewed and parted*

*By screwing in to test plug on the rig floor it eliminates manual handling of the test plug however it causes the tool joints above to reverse torque*
